Simulated Solar Flare X-Ray and Thermal Cycling Durability Evaluation of Hubble Space Telescope Thermal Control Candidate Replacement Materials

Kim K. de Groh and Bruce A. Banks
Lewis Research Center, Cleveland, Ohio

National Aeronautics and
Space Administration

Lewis Research Center

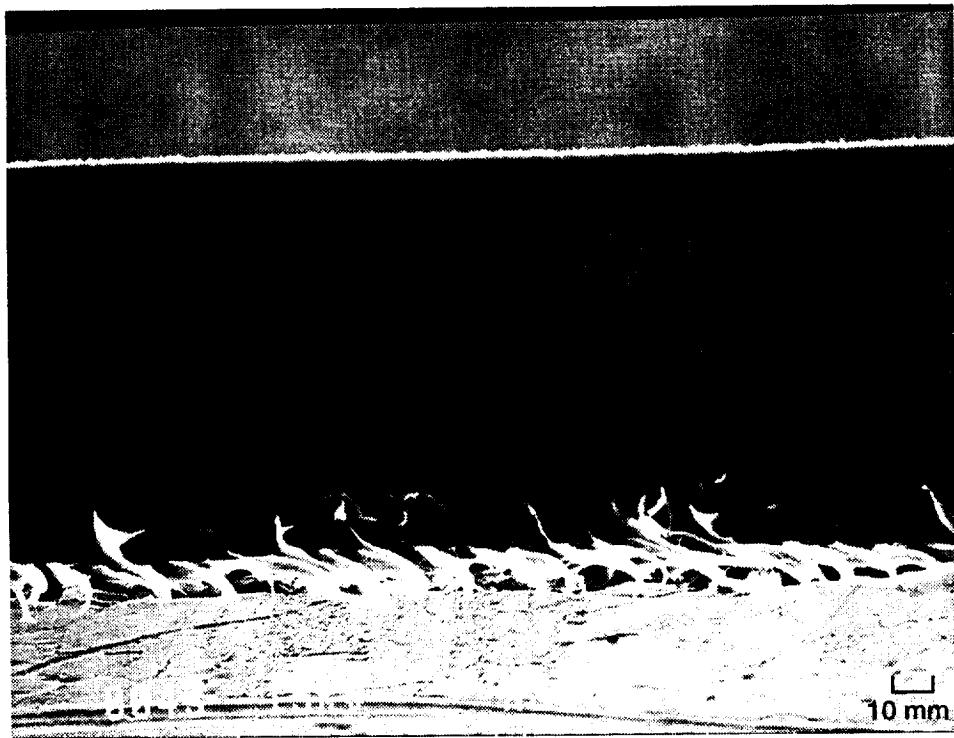
Figure 12. SM2 FEP after bending the space exposed FEP surface in tension. The tension induced fast-propagated crack has a fibrous, textured surface morphology.
